Analysis and Treatment of Deformation Characteristics of a Landslide

Zeng Yuping

Sichuan College of Architectural Technology, Deyang, Sichuan, China

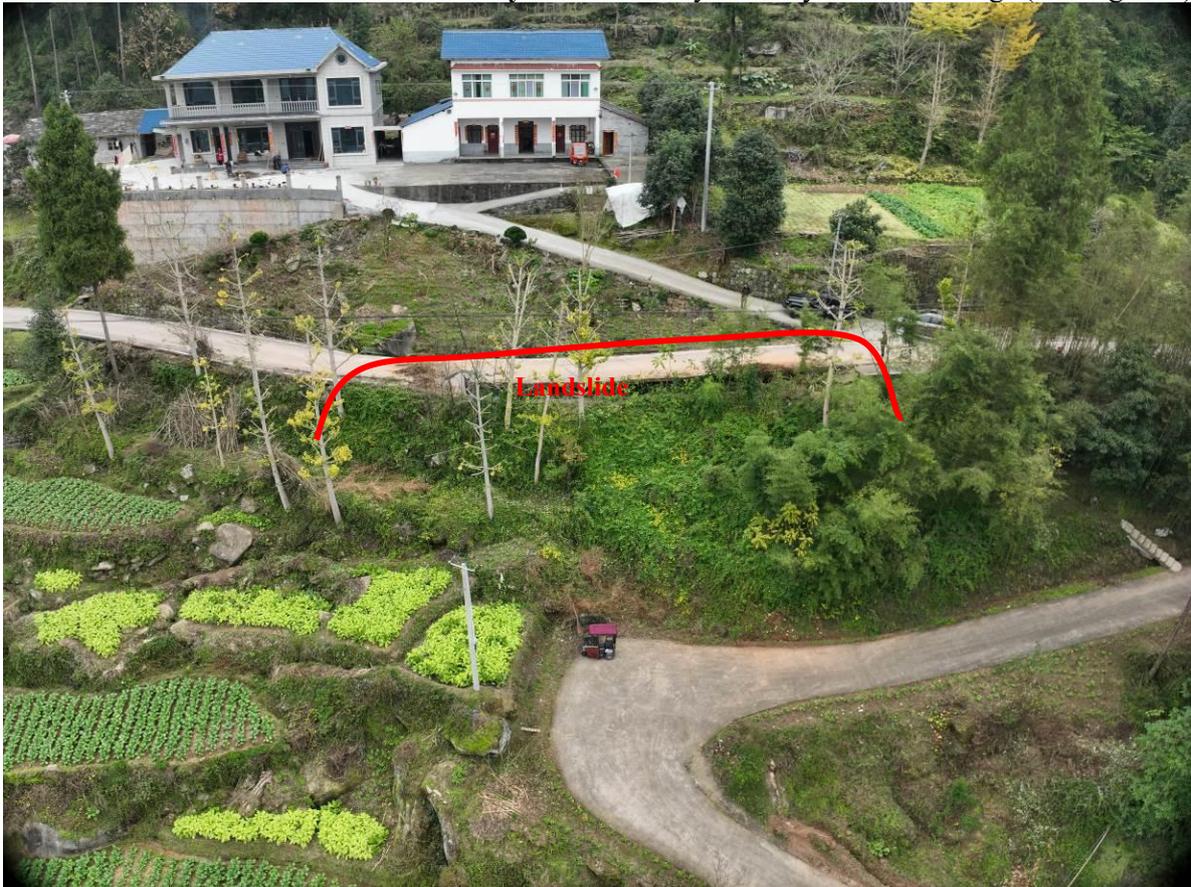
The landslide is located in Guangyuan City, Sichuan Province. Its plane shape is "circular chair-like", with a width of about 35m, an average sliding length of 5.5m, an average thickness of about 3.0m, and a cubic volume of about 580m³. The main sliding direction is about 283°. The rear edge of the landslide is located at the highway platform, and the front edge exits at the steep toe of the roadbed. The deformation manifestations of the landslide mainly include cracking and displacement of the highway pavement at the rear edge, inclination of trees on the landslide slope, and collapse and bulging of the dry masonry at the front edge (See Figure 1).

Figure 1. Landslide Panorama

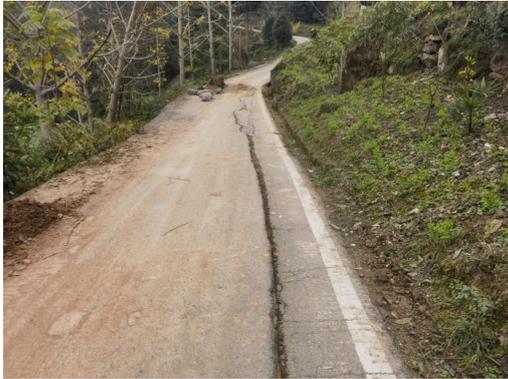
There are mainly two tensile cracks at the rear edge of the landslide(see Figure 2 and 3.), in which L1 strike is about 15, the extension is about 25m, the dislocation is 2cm~8cm, and the crack is 2cm~5cm wide, which leads to the

Figure 2. Landslide Trailing Edge L1 Crack Photo

cracking of the road at the rear edge of the landslide and is the last tensile crack of the landslide. L2 strike is about 20, and the extension length is about 35m. This crack causes the road to be interrupted and the bottom of the road to be hollowed out, with an offset scarp of about 1.0 m. see Figure 4 and 5.

In view of the characteristics of this landslide, it is proposed to adopt active protective measures to protect the threatened objects at the front edge of the landslide. Specifically, a new anti-slip concrete retaining wall will be constructed at the front edge of the landslide; the cracked and damaged pavement at the rear edge of the landslide will be demolished and reconstructed, and the hollowed-out subgrade will be backfilled. These measures can provide sufficient anti-sliding resistance for the landslide and prevent subsequent rainfall from continuously infiltrating along the cracks, so as to achieve the purposes of slope support, landslide prevention and control, and protection of villagers' houses and the village-access highway.

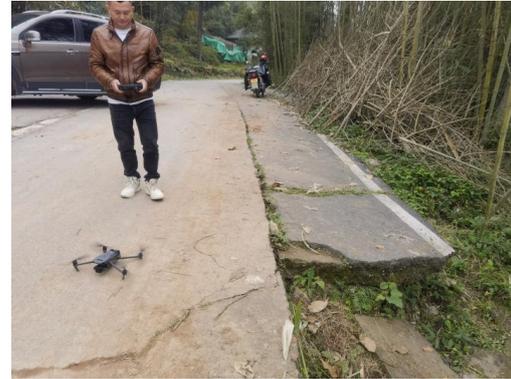
Figure 3. Landslide Trailing Edge L2 Crack Photo

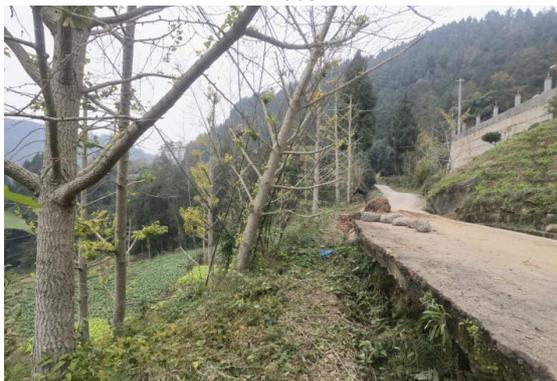
Figure 4. Crack L2 Leads to Road Dislocation

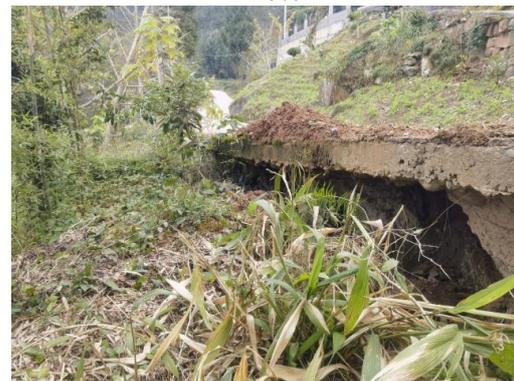
Figure 5. Crack L2 Leads to Road Subgrade Hollowing

For the road subgrade collapse outside the highway, a scheme of constructing road masonry for repair is adopted. The emergency treatment of this landslide adopts the comprehensive treatment scheme of "new anti-slip retaining

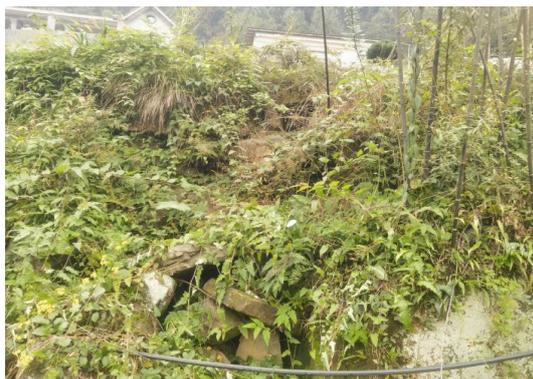
Figure 6. The Mortar Masonry Retaining Wall at the Front Edge of Area 1 # Swells

The front edge of the landslide is a dry block stone retaining wall, with a height of about 3.5m and a thickness of about 0.5m. Under the deformation of the landslide, the retaining wall swells locally, and the bulwarks at local

positions collapse. see Figure 6.

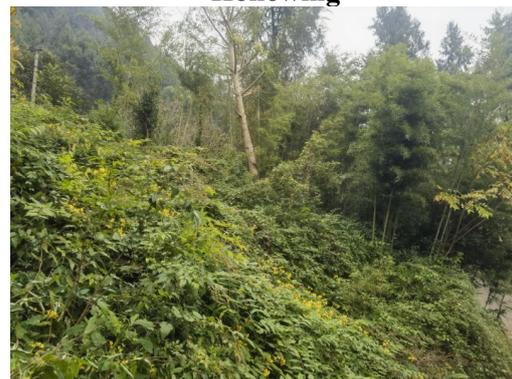
Signs of tree inclination can be seen in the local area of the front slope in the landslide. see Figure 7.

Figure 7. Landslide Slope Surface Trees Tilt
