Research on Identification of Rider-Passenger Relationship in Two-Wheeler Traffic Accidents Based on Kinematics and Trace Examination

2. Basic Accident Information

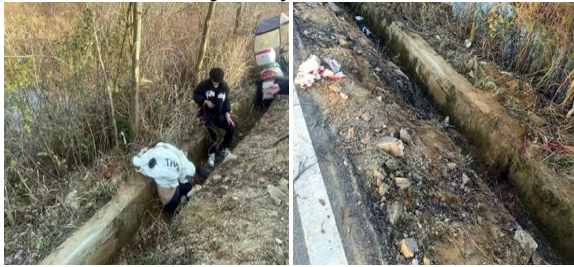
Figure 1. Scene Posture of the Two-Wheeled Motorcycle

An unuplated two-wheeled motorcycle carrying Li and an unidentified person lost control while traveling through a curved road section and fell into a roadside ditch, resulting in the unidentified person dying at the scene, Li being injured, and the vehicle being damaged.

Key information at the accident scene: Road conditions: the road ran north-south, and the accident section was a right-hand curve. The pavement was dry asphalt, with a roadway width of 5.0 m and a shoulder width of 1.3 m. On the east side of the road there was a concrete ditch 65 cm wide and 40 cm deep, which was the core contact area of the accident. Vehicle status: after the accident, the unuplated two-wheeled motorcycle stood upright in the ditch with its front facing south and rear facing north (Figure 1), and the body as a whole remained in an upright posture. Occupant positions: Li and the unidentified person were both located in the ditch north of the motorcycle. The unidentified person lay prone on the eastern vertical face of the ditch facing east (Figure 2), with the right foot curled against the western vertical face of the ditch and the cotton slipper from the right foot scattered at the bottom of the ditch. Scene traces: obvious scrape marks were present along

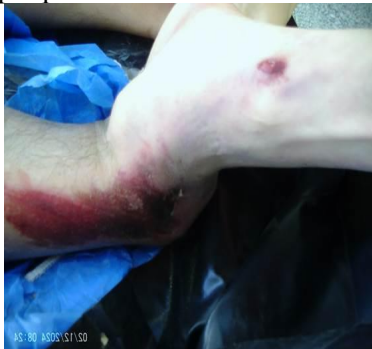
Figure 5. Injury to the Left Ankle of the Unidentified Person

The body length was 182 cm. Bleeding was observed from the mouth, ears, and nose, and a swelling was seen in the occipital region. Poor resistance of the right chest when pressed suggested possible rib fractures. Multiple contusions from the left knee to the ankle, accompanied by an open fracture above the ankle, were observed (Figure 5), with the injury range concentrated on the lateral and distal portions of the left lower limb. Strip-like contused abrasions were seen on the medial side of the left lower leg, and contusions were present on the back of the right hand. The injuries were multi-site and compound in nature, consistent

with mechanisms of collision, compression, and friction.

Left lower-limb injuries: the multiple contusions from the left knee to the ankle and the open fracture of the unidentified person corresponded to the inward compression deformation of the left passenger foot peg. Because the left rear passenger foot peg was located 4 cm below the upper plane on the east side of the ditch, the rear-seat passenger's left foot was exactly between the vehicle and the vertical face of the ditch when the vehicle tipped over. It was compressed and rubbed, producing concentrated injuries on the lateral side of the left lower limb, which fully matched the injury characteristics of multiple contusions from the left knee to the ankle accompanied by an open fracture above the ankle.

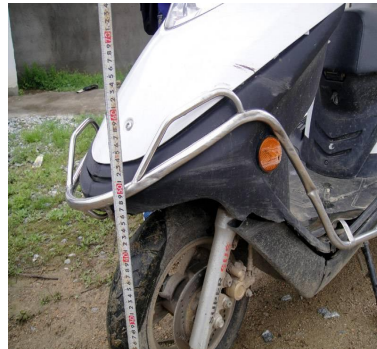
Figure 6. Trace on the Left Front Guard Panel of the Motorcycle

2. Front fairing and front guard panel: scrape marks were present on the left side of the front fairing within the range of 30-60 cm. Collision marks were observed on the left side of the front guard panel at heights of 60-64 cm above the ground, with red primer exposed. The marks showed an oblique linear form that was higher at the front and lower at the rear (Figure 6 and Figure 7). These traces lay on the same line as the trace of the left passenger foot peg (Figure 8), forming a continuous contact-trace chain.

2. Oblique linear trace on the left side of the front guard panel: the oblique feature, higher at the front and lower at the rear, and the connecting line between this trace and the left passenger footboard matched the trace on the

eastern vertical face of the ditch. Considering the angle between the vehicle's travel direction and the ditch, this trace could be determined to have been formed by collision between the left front guard panel and the eastern vertical face of the ditch as the vehicle fell to the left after the front wheel entered the ditch.

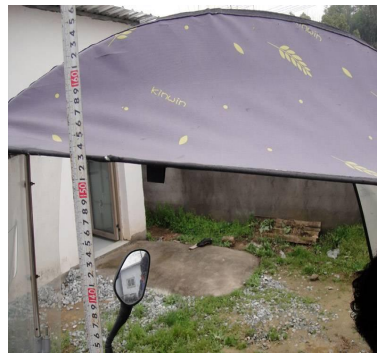
Figure 10. Trace on the Left Side of the Sunshade Canopy

4. Handlebar and sunshade canopy: the end of the left handlebar was damaged, with soil adhering to the damaged area. Scrape marks running from front to rear were observed on the left edge of the sunshade canopy at a height of approximately 153 cm above the ground (Figure 10).

4. Scrape marks on the left edge of the sunshade canopy: the scrape marks at a height of 153 cm above the ground matched the position and direction of the scrape marks at a height of 60 cm on the west side of the tree east of the ditch. This proved that, when the vehicle fell to the left, the left side of the sunshade canopy scraped laterally against the tree, supplementing a key node in the vehicle's overturning trajectory.

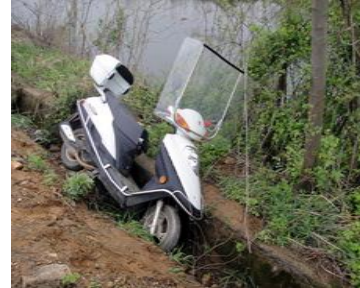
Figure 11. State of the Motorcycle during the Accident

5. Trace alignment verification: when the front and rear traces on the left side of the vehicle

were aligned with the traces on the eastern vertical face of the ditch, the left rear passenger foot peg was located approximately 4 cm below the upper plane on the east side of the ditch. This

indicated that this part had scraping contact with the eastern vertical face of the ditch during the accident (Figure 11 and Figure 12).

After the front wheel fell into the ditch, the right front portion of the crash bar collided with the upper edge of the western vertical face of the ditch, producing the first contact point. Because the vehicle was unstable, its center of gravity shifted, and inertia acted on it, the vehicle began

to tip to the left. During this process, the left front crash bar and the left front guard panel continuously scraped against the eastern vertical face of the ditch, forming an oblique collision mark on the left front guard panel. Meanwhile, the left side of the sunshade canopy contacted the tree east of the ditch, forming scrape marks on the west side of the tree.
